SUBJ: RCRA Compliance Evaluation Inspection  
Safety Kleen Systems, Inc.  
EPA ID Number: ALD981028798

## **RCRA Inspection Report**

**SAFETY KLEEN SYSTEMS, INC.**

**COMPLIANCE EVALUATION INSPECTION PHOTOGRAPHS**

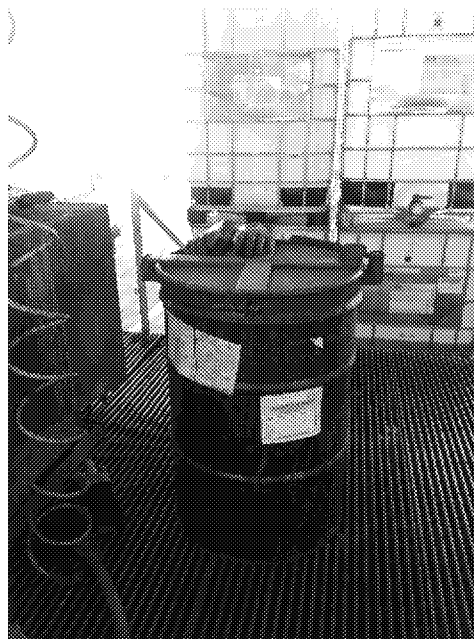
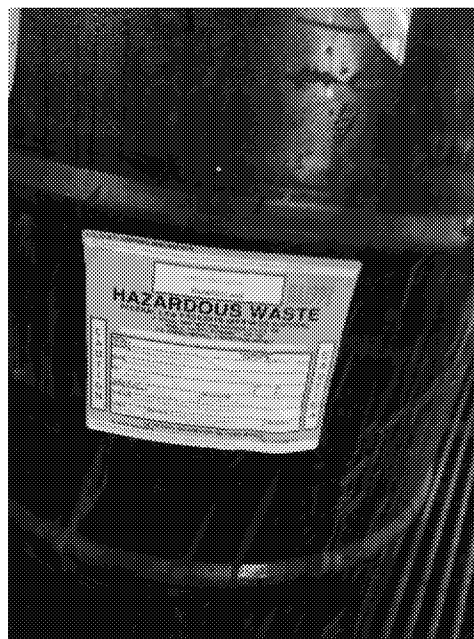
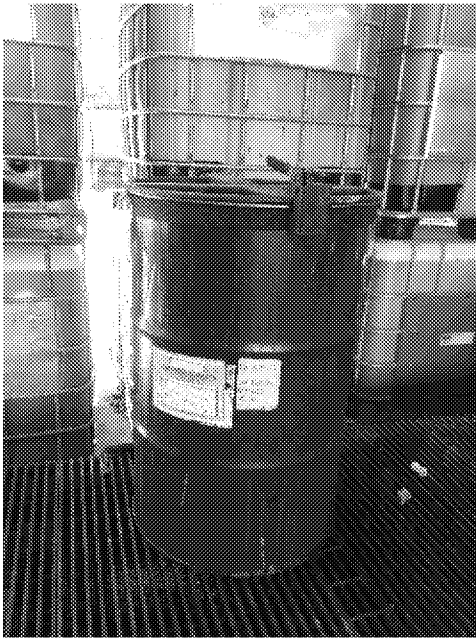
The inspectors observed two 55-gallon satellite accumulation area (SAA) drums of Solvent Sludge – Branch Generated (Pictures 4-7). The drums were observed closed and labeled.

Picture [ SEQ Picture \\* ARABIC ] – Dumping Field SAA

Picture [ SEQ Picture \\* ARABIC ] – Dumping Field SAA label

Picture [ SEQ Picture \\* ARABIC ] – Dumping Field SAA  
label

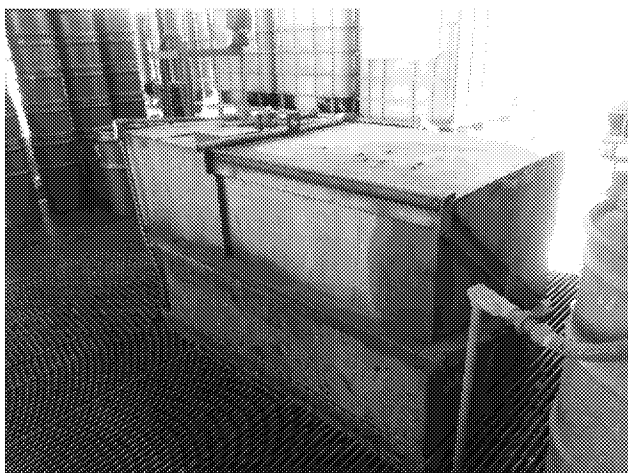
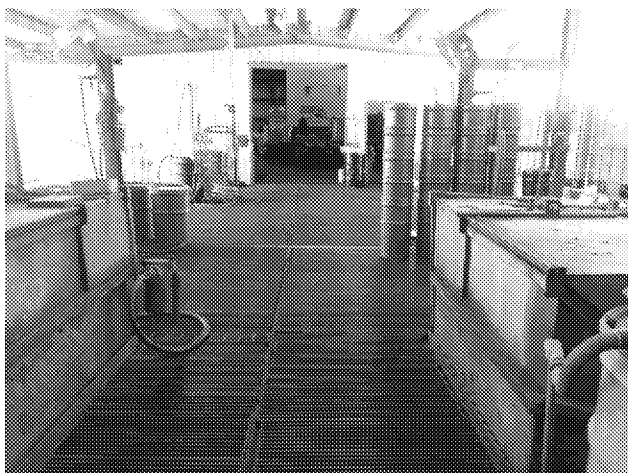
The Dumping Field is a grated secondary containment where the incoming spent solvent drums are lined up, and the dirty solvent is pumped out into a yellow tanker truck (Pictures 1-3). The dirty drums are put into a drum washer. If the drum held hazardous waste, then the drum is put in the spritzer and sprayed with Safety Kleen Premium Solvent 150. Once the drum is cleaned, the drum is refilled with new non-hazardous solvent.

Picture [ SEQ Picture \\* ARABIC ] – Dump Tank

Picture [ SEQ Picture \\* ARABIC ] – Dumping Field and Dump Tank

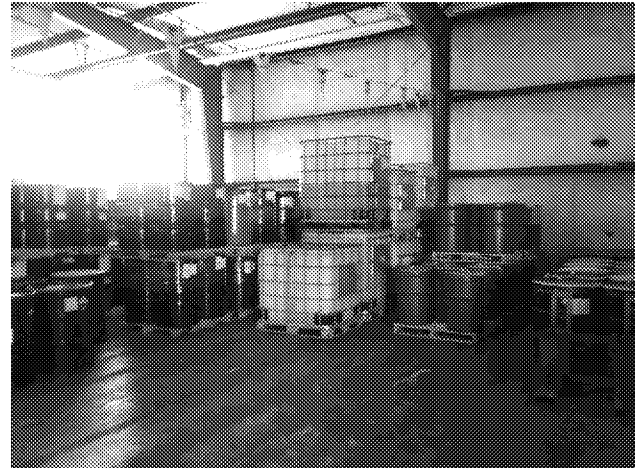
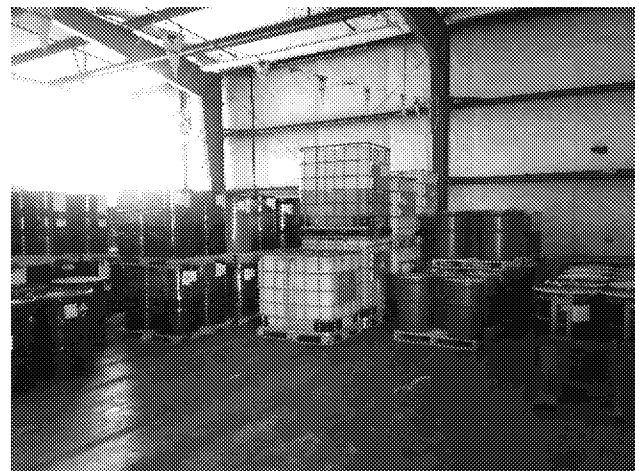
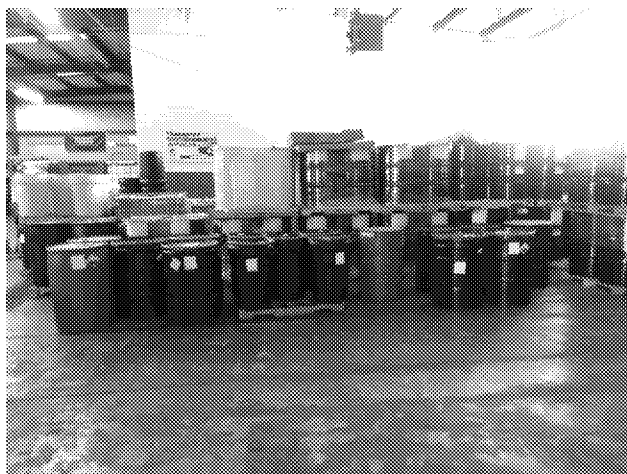
The Warehouse is where the incoming drums are stored before shipping out to other hubs (Pictures 8-11). The inspectors observed the following in the Warehouse (Pictures 8-21, 29):

Picture [ SEQ Picture \\* ARABIC ] – Warehouse

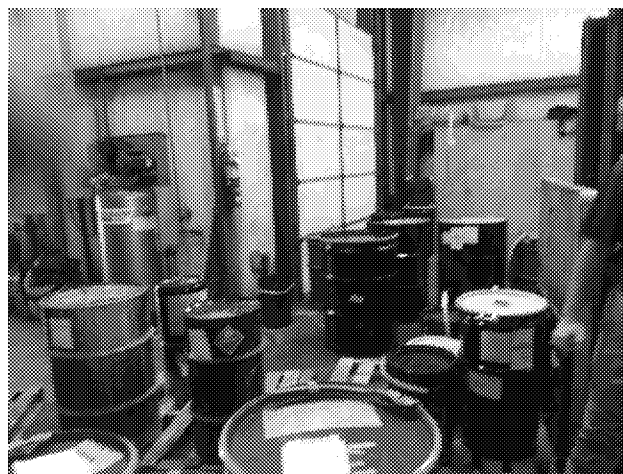
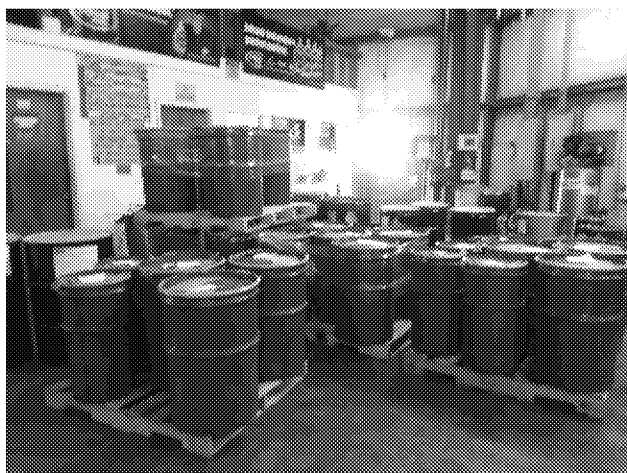
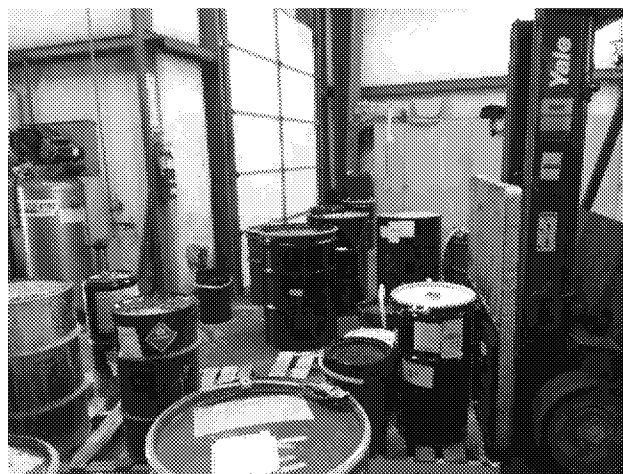
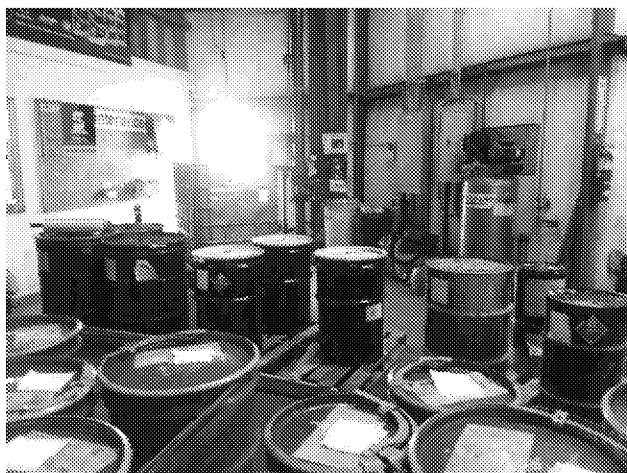
- Red 55-gallon drums with non-hazardous solvent to be pumped out;
- Seven 250-gallon totes of non-hazardous waste;
- Six pallets of non-hazardous waste to be shipped to Clean Harbors in Chattanooga, TN;
- Three pallets of universal waste lamps that were shrink wrapped and ready to ship out to other hubs;
- Drums and totes of aqueous parts washer waste water that will sent to the Clean Harbor waste water treatment plant;
- Three 55-gallon drums of used oil filters next to a blue used oil container for drained filters; and
- Sixteen incoming hazardous waste containers arriving that morning waiting to be processed:

Picture [ SEQ Picture \\* ARABIC ] – Warehouse incoming drums being processed

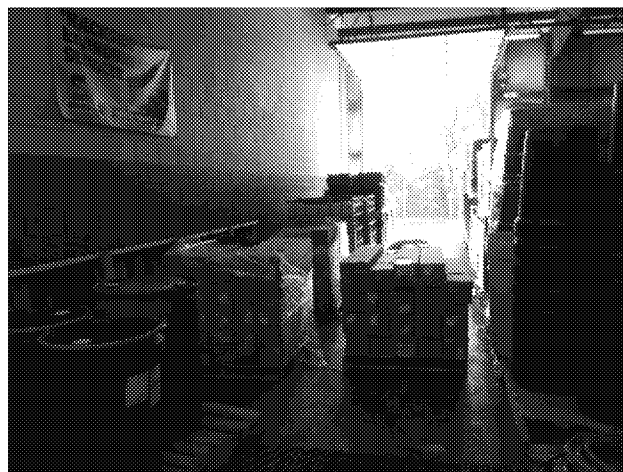
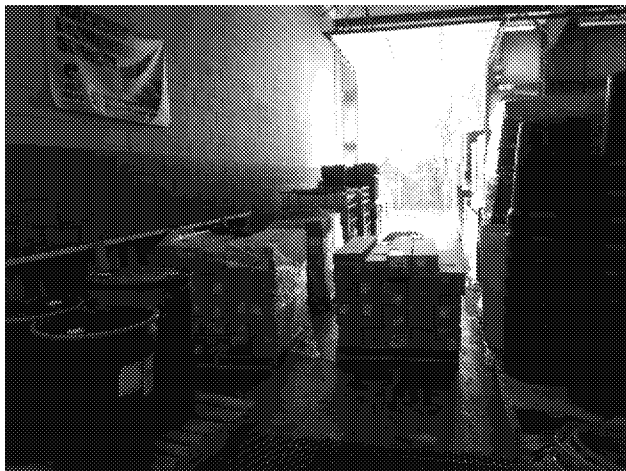
Picture [ SEQ Picture \\* ARABIC ] – Warehouse universal waste lamps

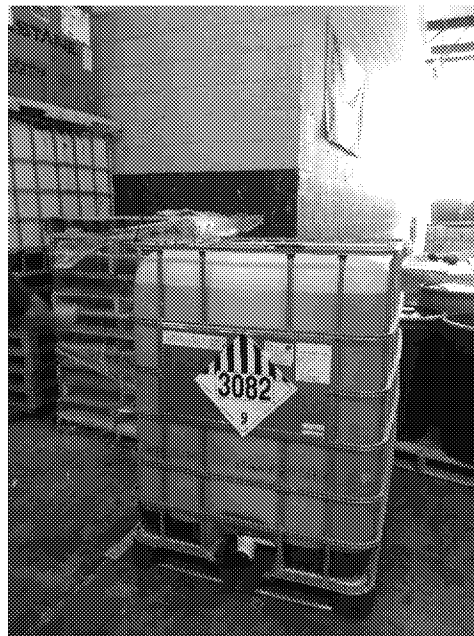
The inspectors reviewed the weekly inspection records for 2016-2019 for the HWSA, and the daily inspection records the storage tank/tanker system. In addition, the inspectors reviewed the 10-Day Yard Tracking Logs for a 250-gallon tote label selected from the Warehouse. The inspectors observed the tote was brought in on April 15, 2019 and the tracking noted the generator and the disposal facility. No issues were noted during the review.

Picture [ SEQ Picture \\* ARABIC ] – Warehouse tote

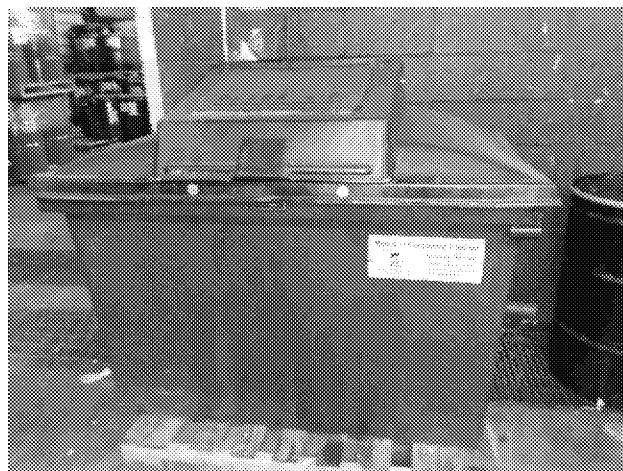
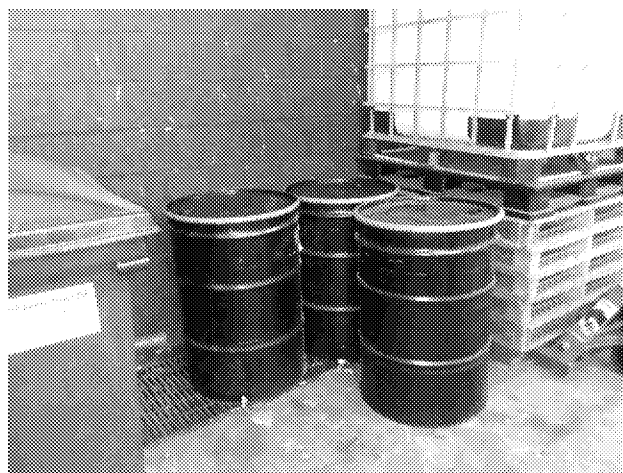
Picture [ SEQ Picture \\* ARABIC ] – Warehouse used oil filters

Picture [ SEQ Picture \\* ARABIC ] – Warehouse used oil filter drums

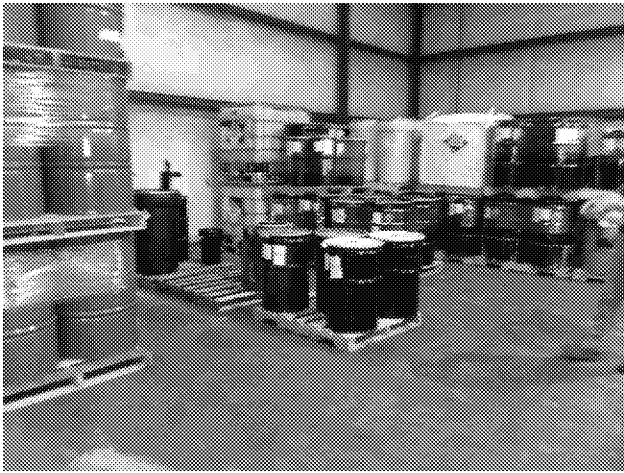
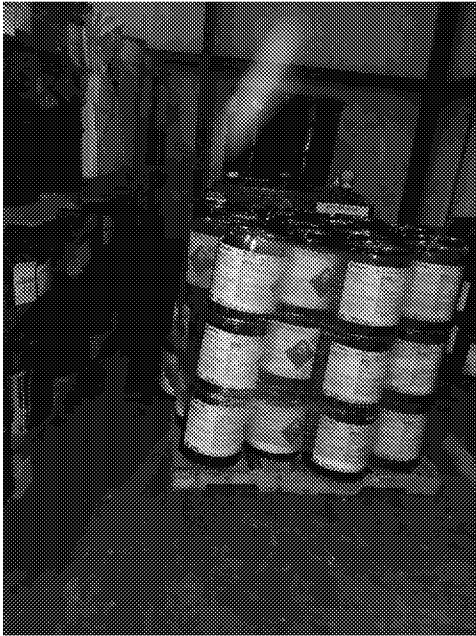
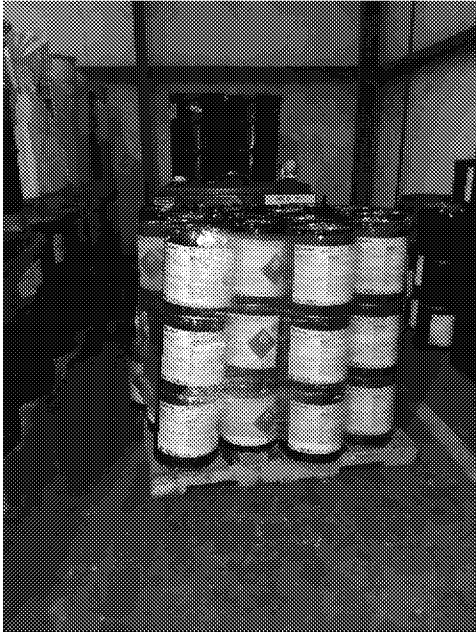
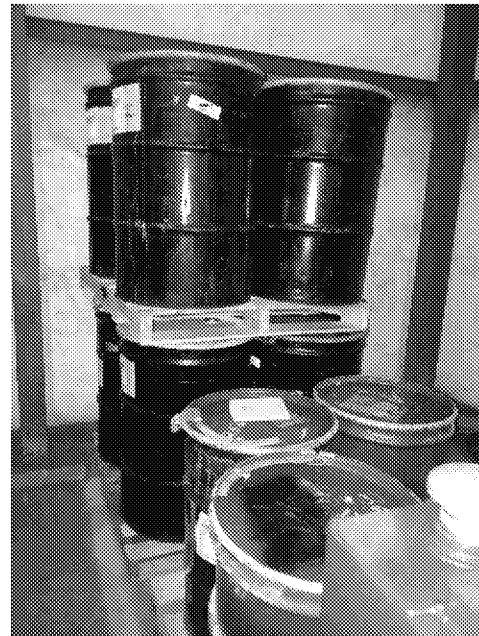
The Flammable Room was used to stage outgoing container loads, for storage of waste and oil samples for up to 3 months and as the branch less than 90-day hazardous waste storage area (HWSA). The inspectors observed container of hazardous flammable waste, universal waste lamp containers, a 55-gallon drum of purged hazardous oil samples that was open, a used oil tank, eleven 55-gallon drums of branch generated hazardous waste stacked on two pallets and three 35-gallon drums of branch generated hazardous waste (Pictures 22-28, 38-40). The HWSA containers were closed, labeled and dated. The oldest drum was dated February 8, 2019. The open purged samples container was immediately closed by the facility during the inspection.

Picture [ SEQ Picture \\* ARABIC ] – Flammable Room and HWSA

Picture [ SEQ Picture \\* ARABIC ] – Flammable Room HWSA

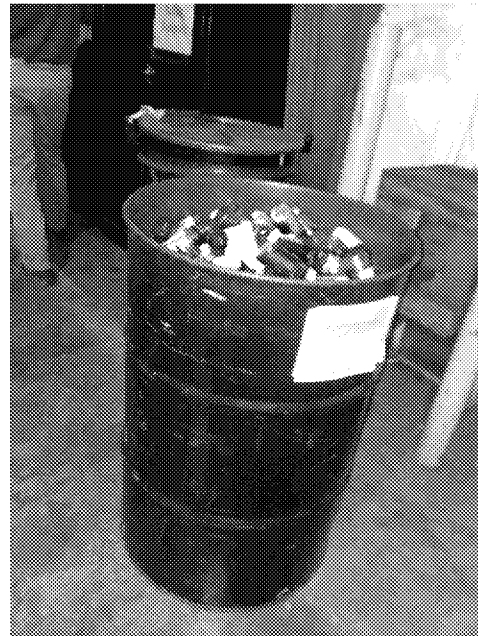
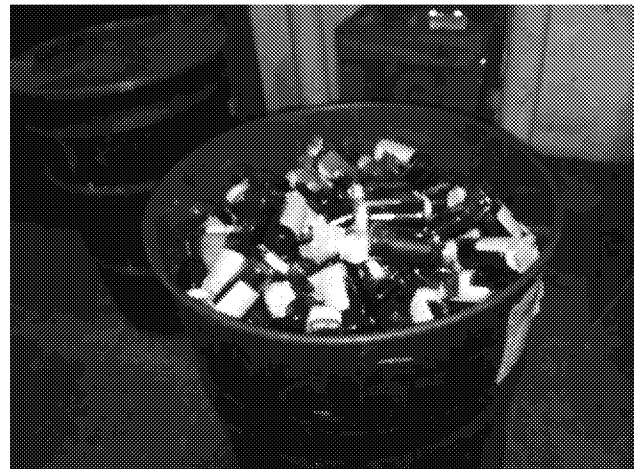
Picture [ SEQ Picture \\* ARABIC ] – Flammable Room purged samples

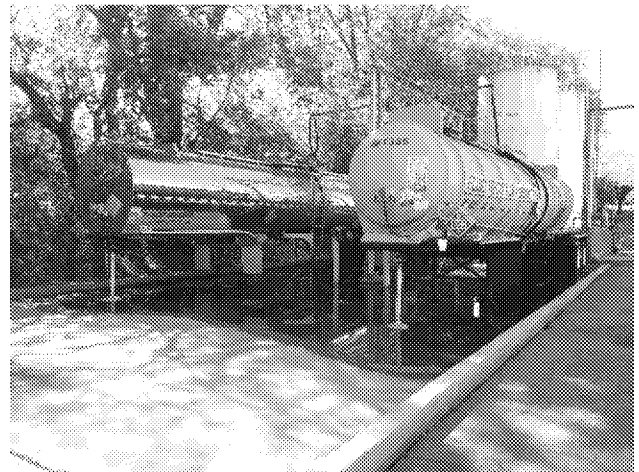
Dirty solvent is stored in a 7,000-gallon yellow tanker (Pictures 30-31). The tanker sits inside a sloped secondary containment. The tanker was marked with a hazardous waste label and dated April 11, 2019. Mr. Boyd explained that the hazardous waste tanker would be shipped to Clean Harbors in Lexington, SC, pumped out, cleaned and refilled with clean solvent to distribute to their clients.

Picture [ SEQ Picture \\* ARABIC ] – Tanker Storage

Picture [ SEQ Picture \\* ARABIC ] – Tanker Storage label

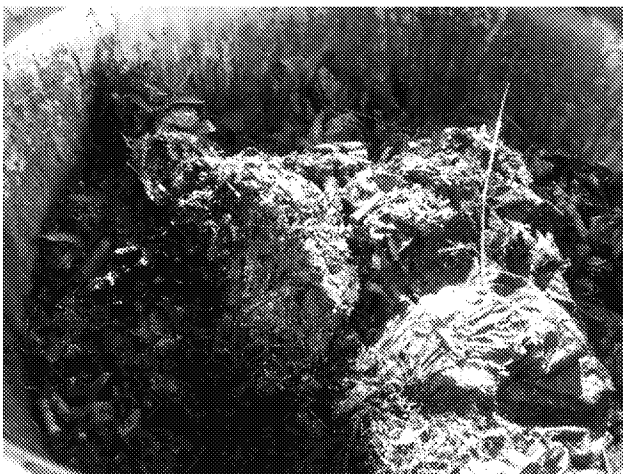
Picture [ SEQ Picture \\* ARABIC ] – Tank Farm used oil drum debris
